Categorical Exclusion
Appendix H
Air Quality

Categorical Exclusion
Appendix I
Other Information

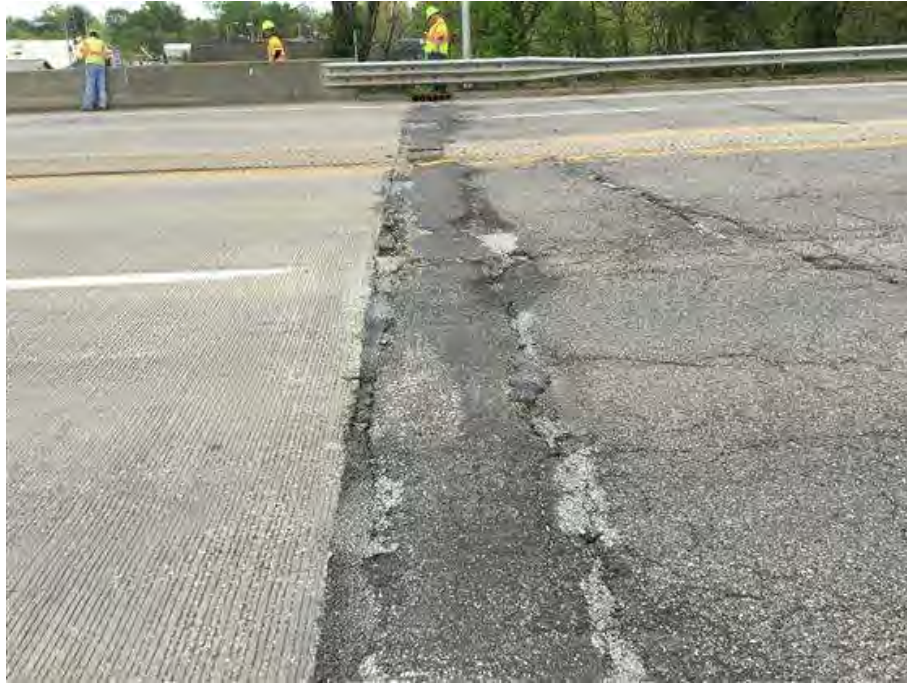
PHOTO 3

Description West end of approach covered terminal joint exhibits spalling in bituminous.

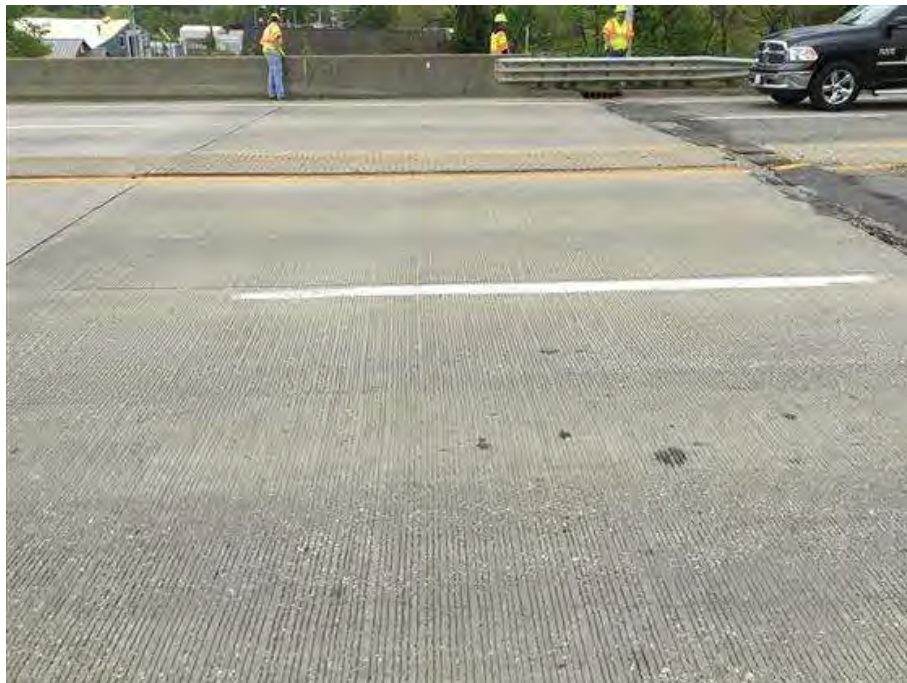
PHOTO 4

Description West Concrete Approach conditions; notice on west bound right lane exhibits a minor longitudinal full length crack.

West Concrete Approach exhibits on west bound right lane exhibits a minor longitudinal full length crack.

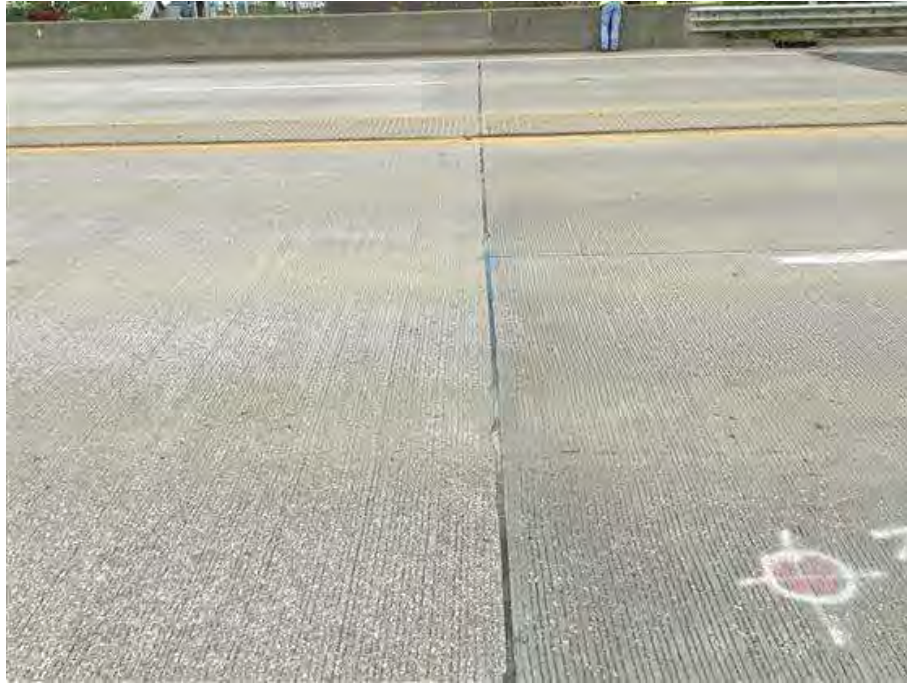
PHOTO 5

Description West type Pourable Deck Joint conditions.

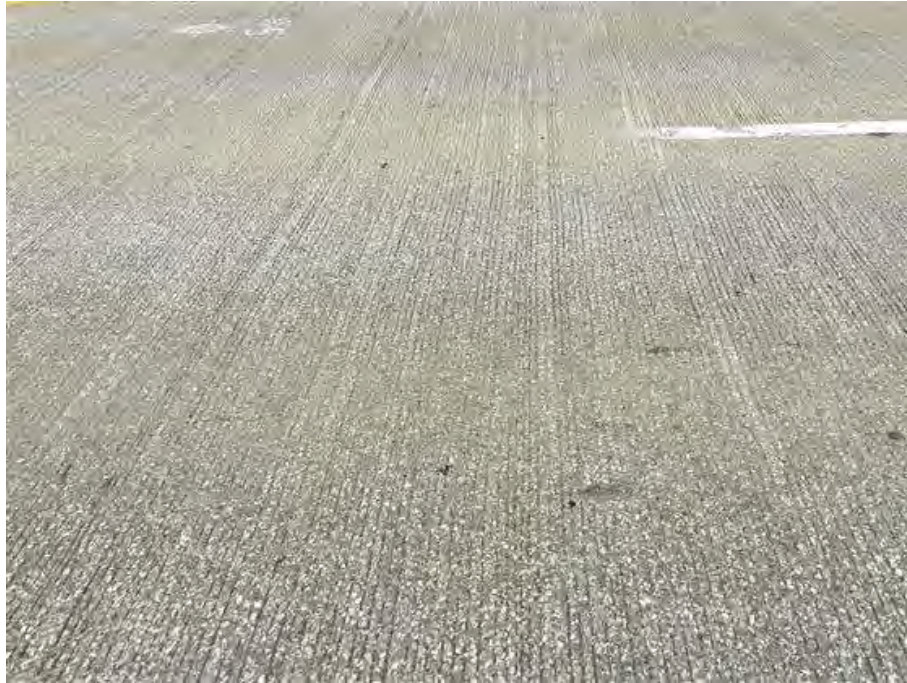
PHOTO 7

Description Intermittent minor width transverse cracks mainly through center of structure.

Plans specify overlay with microsilica and corrosion inhibitor. Appeared predominantly sound. Intermittent minor width transverse cracks mainly through center of structure. Spot chaining done in 2018 did not detect any delamination. Traffic volume is high and full surface chaining is very difficult to do safely.

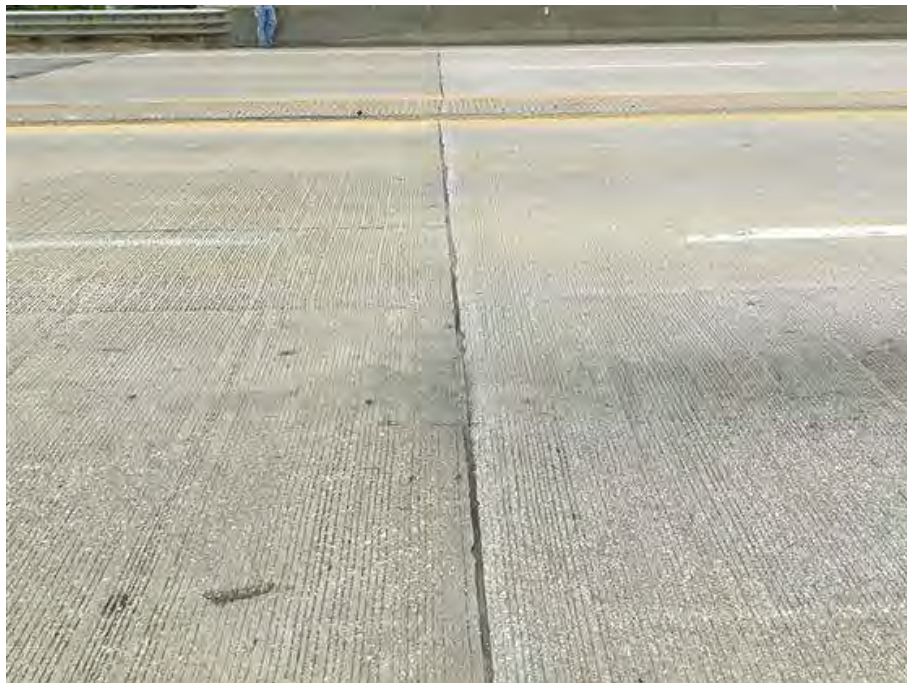
PHOTO 8

Description East type Pourable Deck Joint conditions.

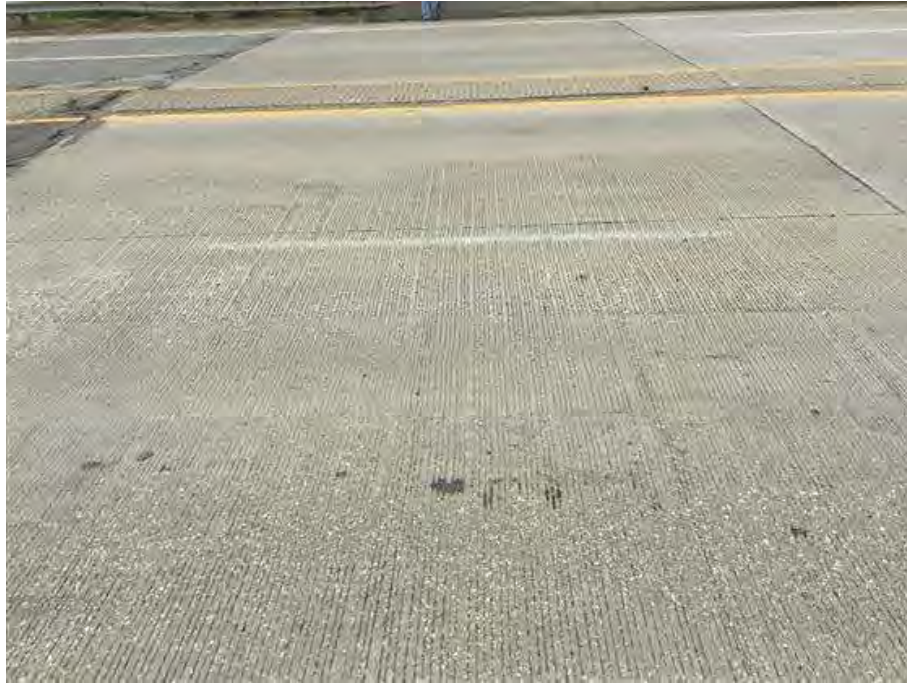
PHOTO 9

Description East Concrete Approach conditions.

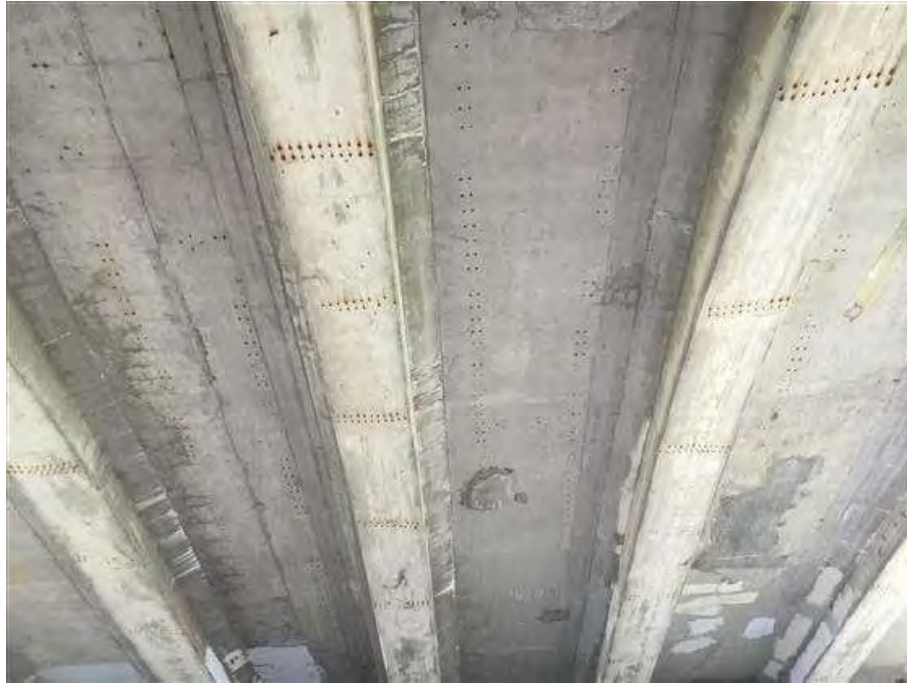
PHOTO 11

Description Underside Span A overall condition.

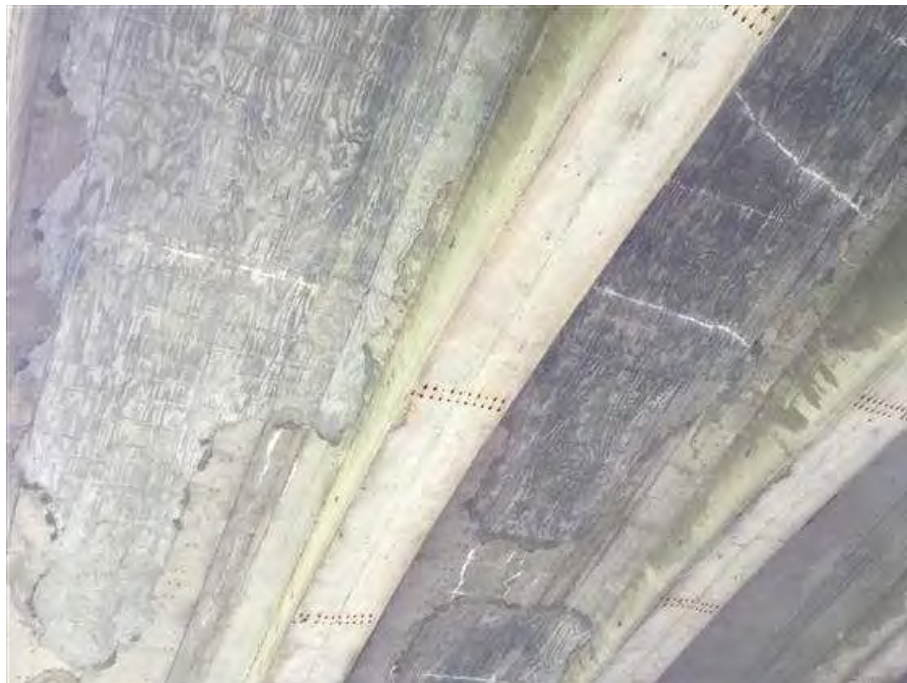
PHOTO 12

Description Underside Span A exhibits a few small spall with exposed reinforcement, cracking with light efflorescence and or delamination in areas.

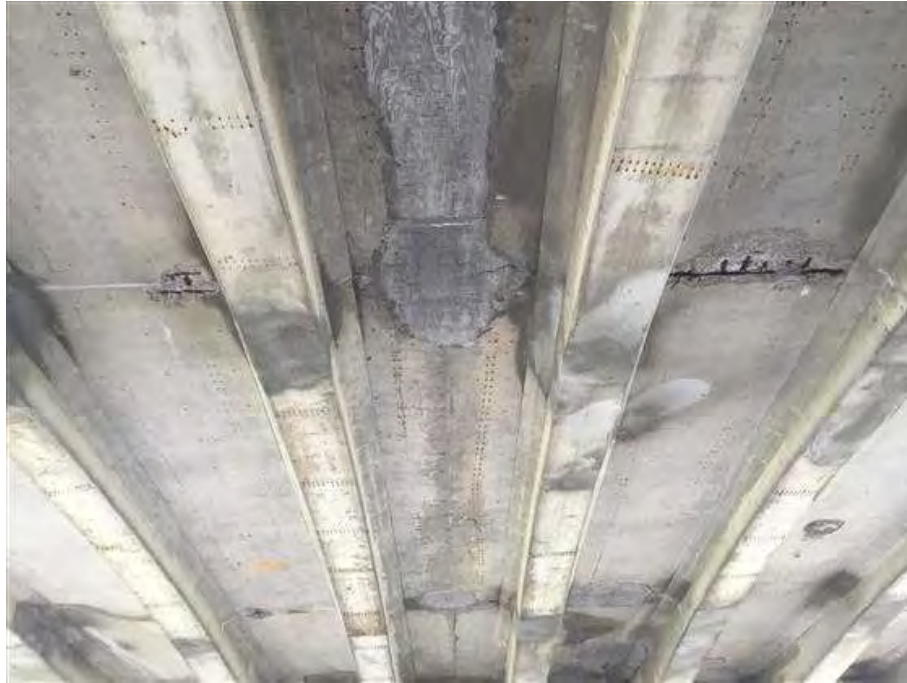
PHOTO 13

Description Underside Span B overall condition; notice almost all typical beams exhibit small delamination/cracking in areas.

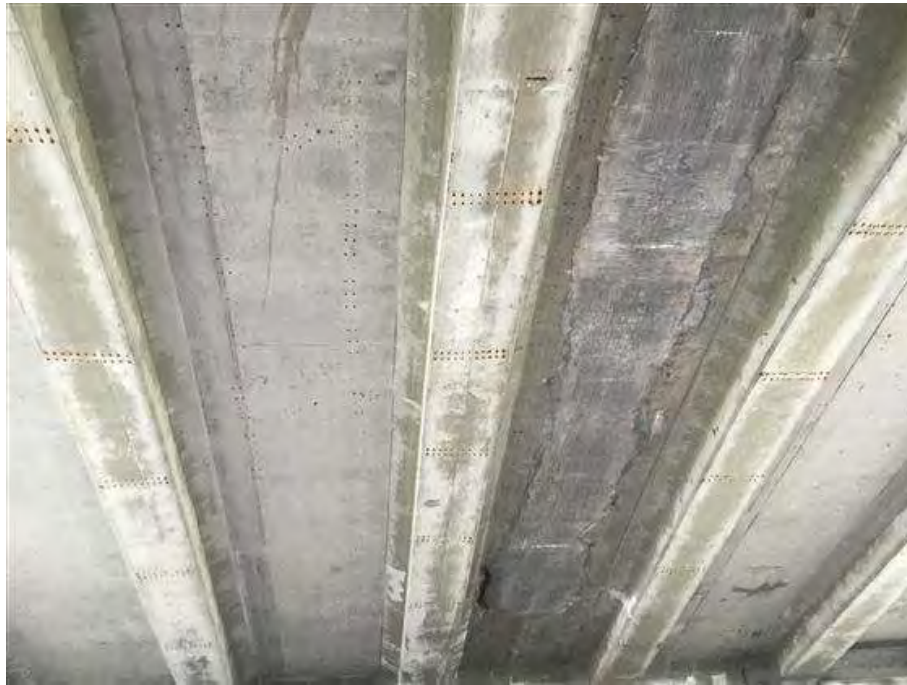
PHOTO 19

Description Underside Span C overall condition.

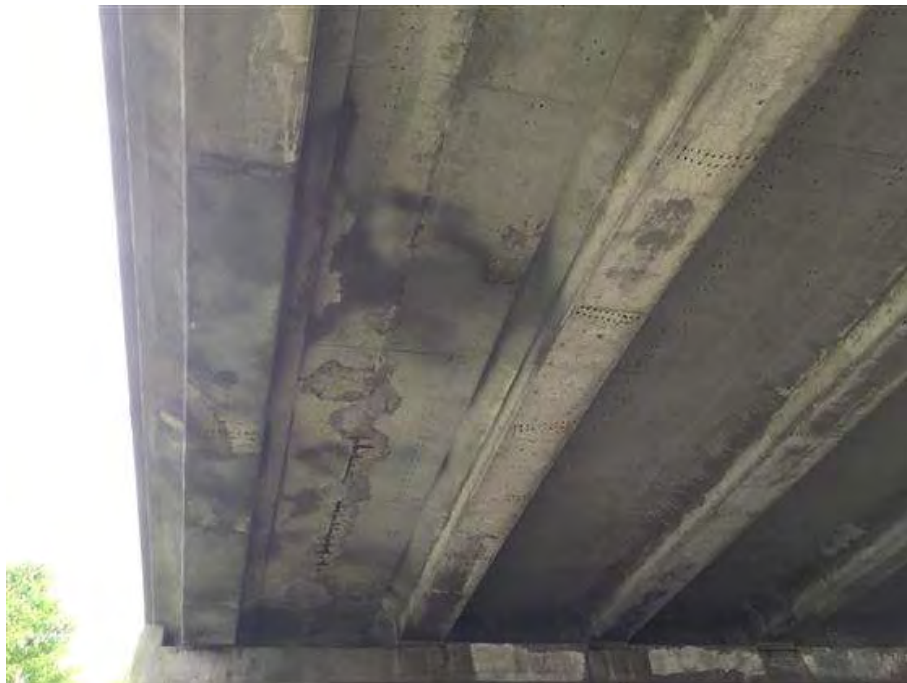
PHOTO 20

Description East fascia beam and bay 7 exhibits areas of spalling with exposed reinforcement and cracking bay 7 exhibits approximately 20 SFT of spalling with exposed reinforcement and beam approximately 4 SFT of delamination, spalling and or cracking .

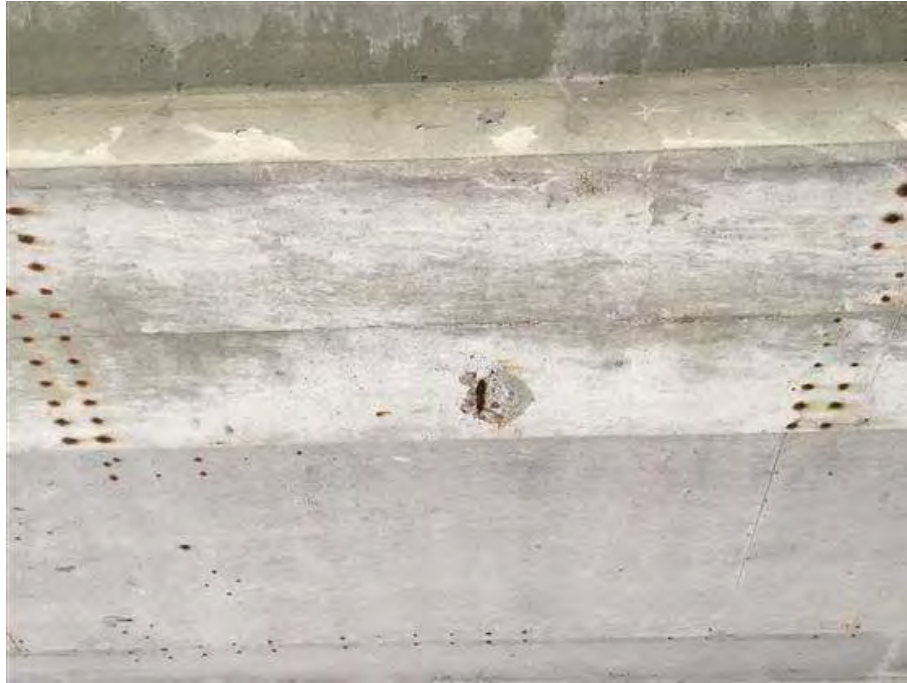
PHOTO 21

Description Beam 5 in span C exhibits a few areas of small spalls over reinforcement due to lack of coverage, a few on other beams also.

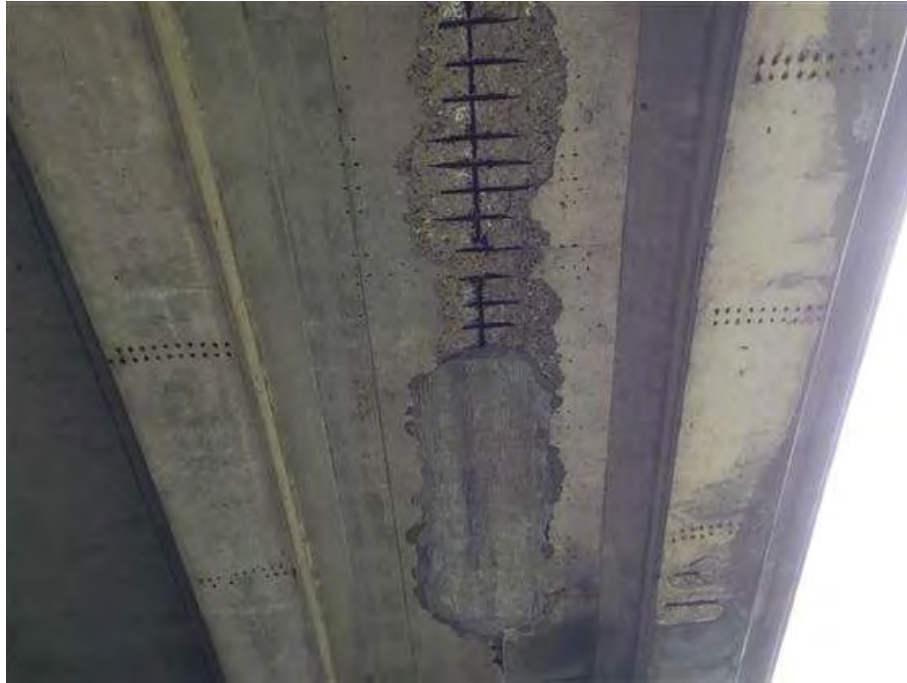
PHOTO 23

Description Beam 1 and bay 1 in span C exhibits spalling with exposed reinforcement beam 1 exhibits approximately 5 SFT of spalling and bay 1 exhibits approximately 20 SFT of spalling with exposed reinforcement.

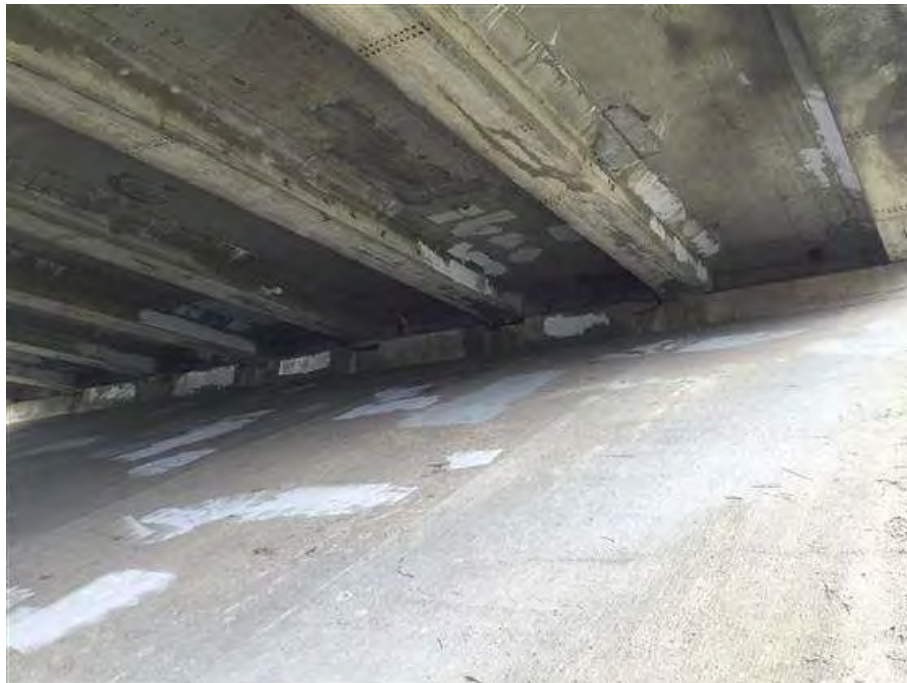
PHOTO 24

Description Abutment 1 overall condition.

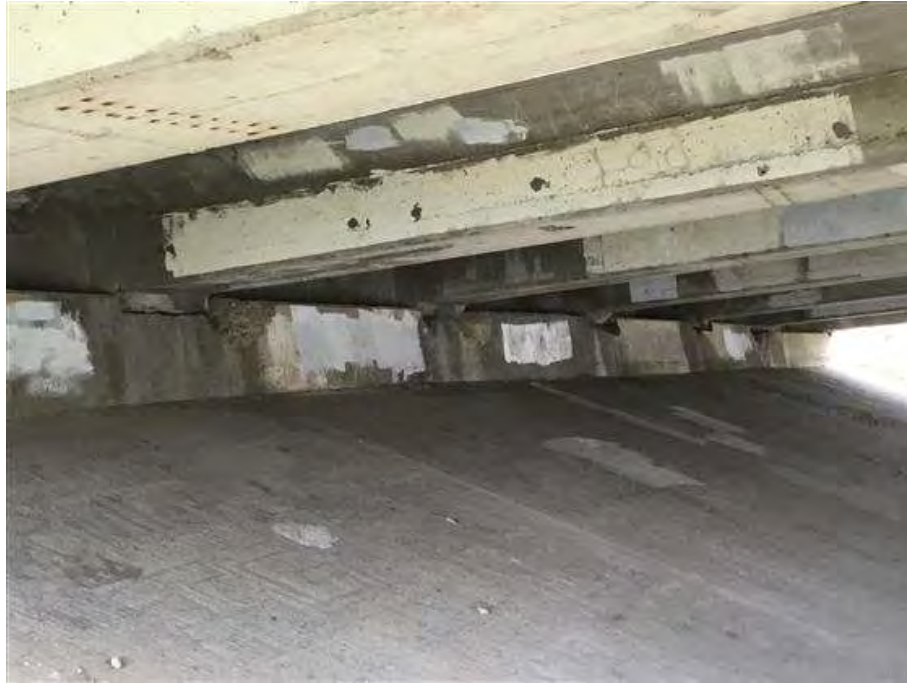
PHOTO 25

Description Abutment 1 exhibits areas approximately 5 SFT spalling.

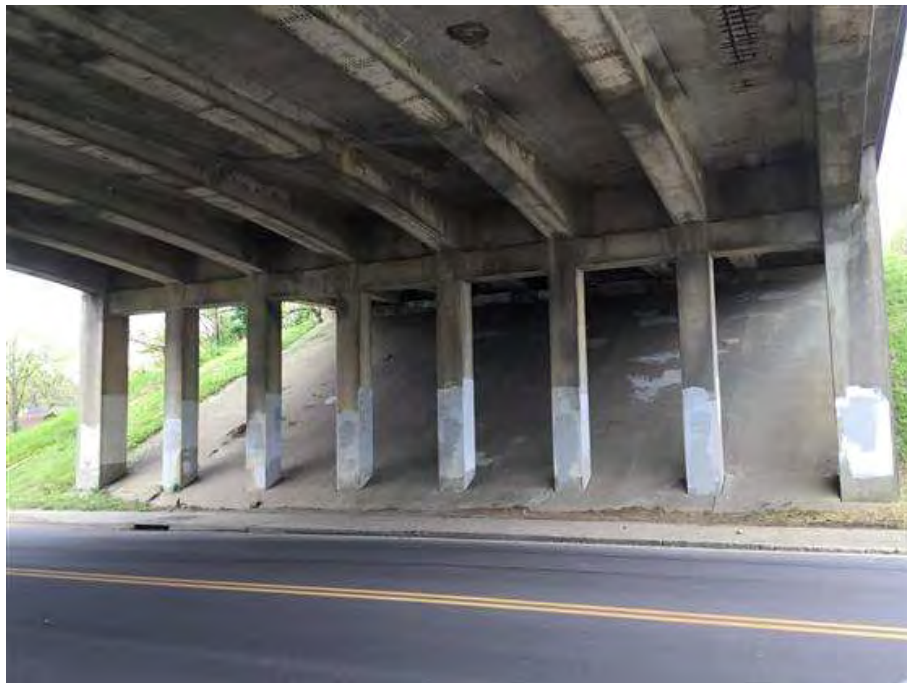
PHOTO 26

Description Pier 2 overall condition.

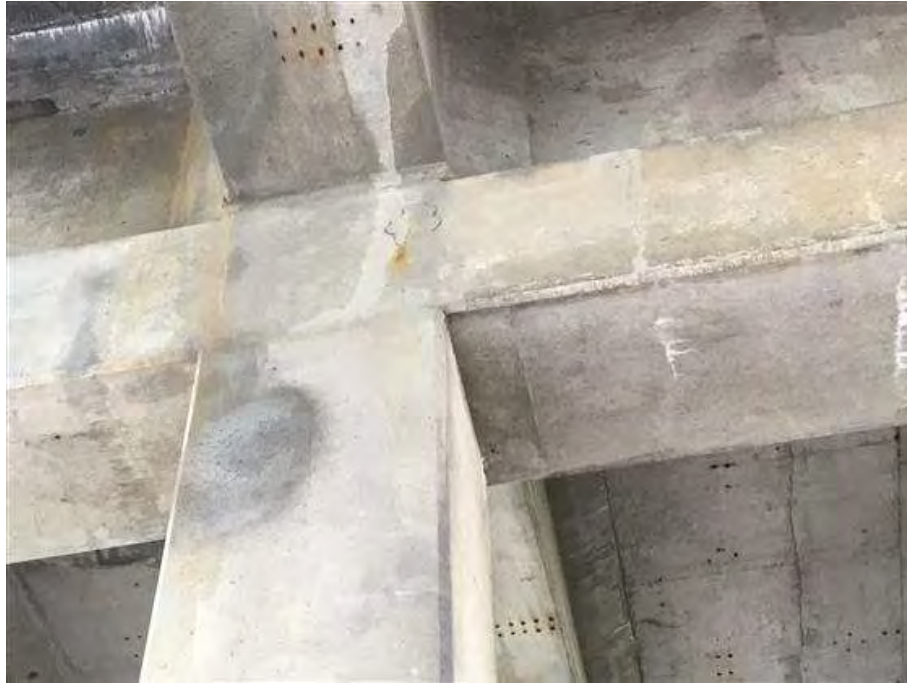
PHOTO 27

Description Small delamination/ cracking areas on Pier caps.

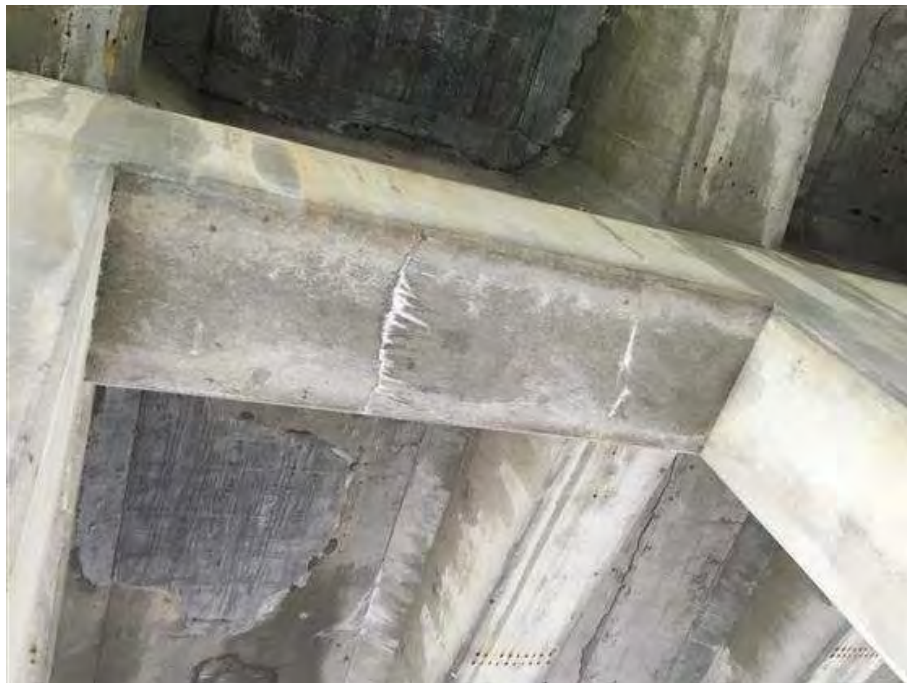
PHOTO 28

Description A few fine cracks with light efflorescence on bottom of pier caps.

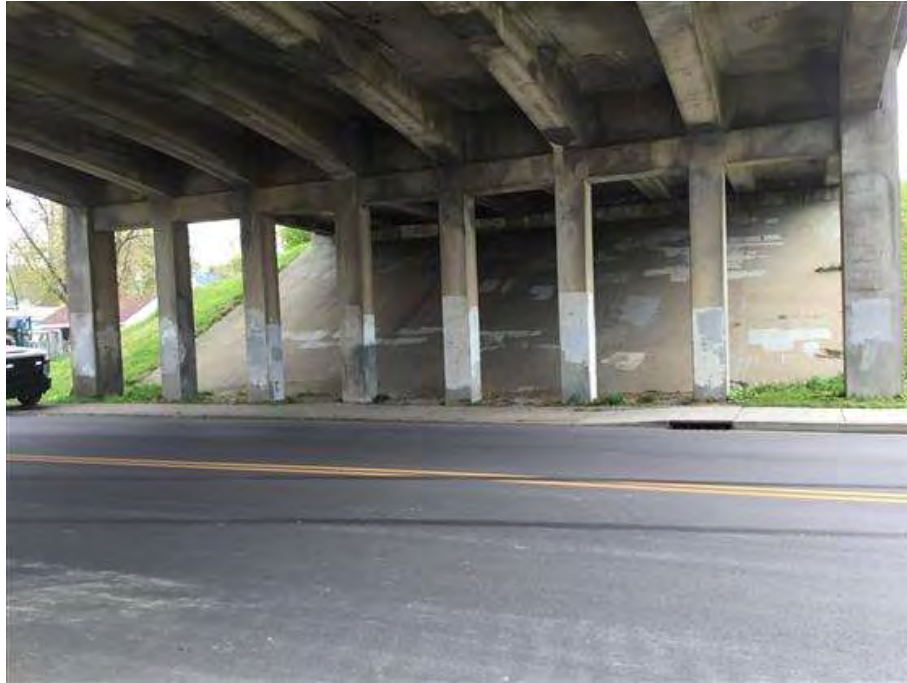
PHOTO 29

Description Pier 3 overall condition.

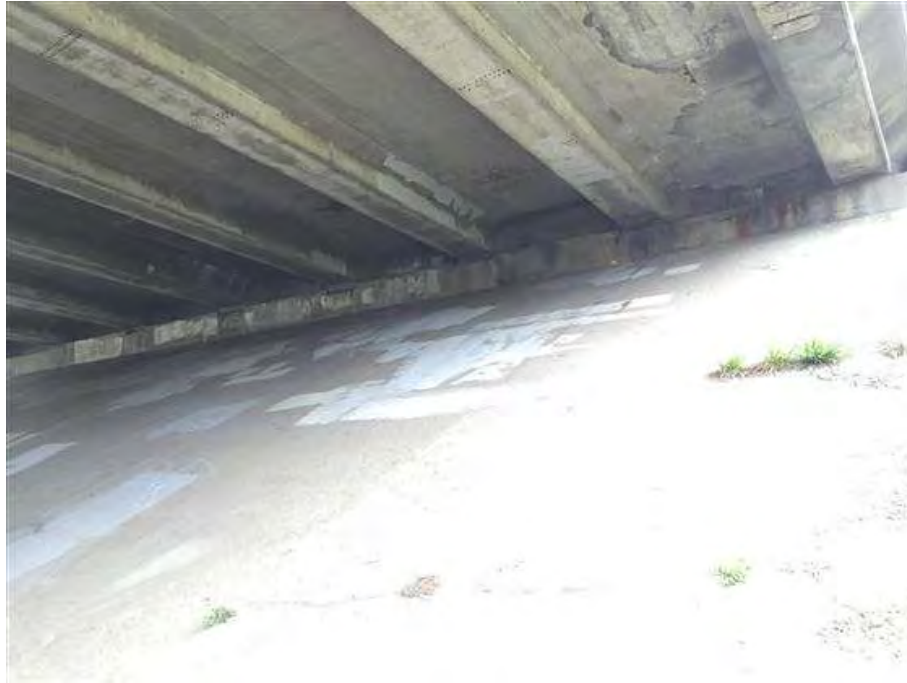
PHOTO 31

Description Abutment 4 overall condition.

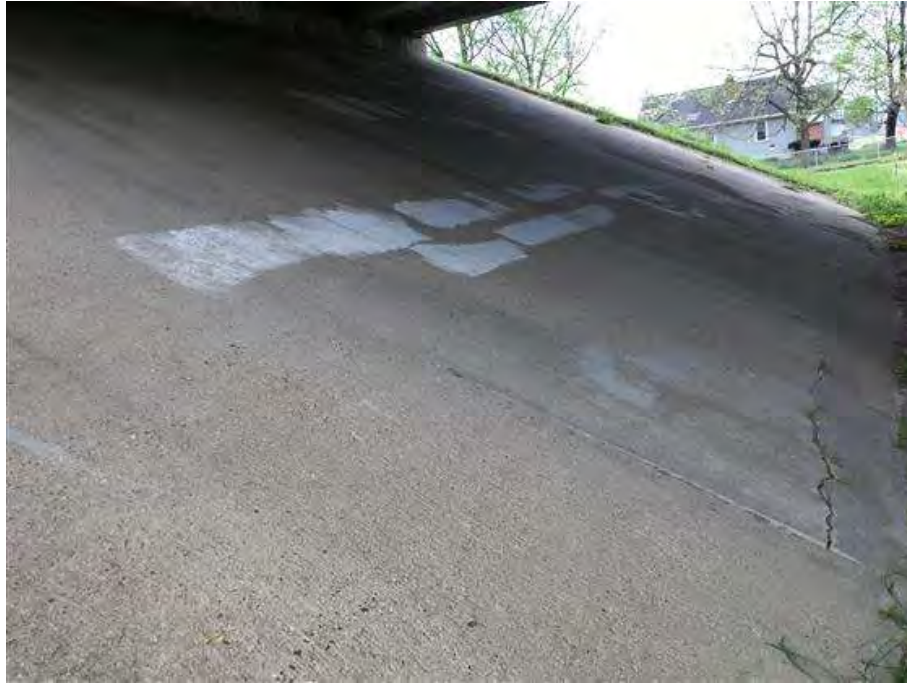
PHOTO 33

Description Typical condition of both concrete Slope walls notice some minor to moderate width cracking with very little settlement.

Typical condition of both concrete Slope walls notice some minor to moderate width cracking with very little settlement.

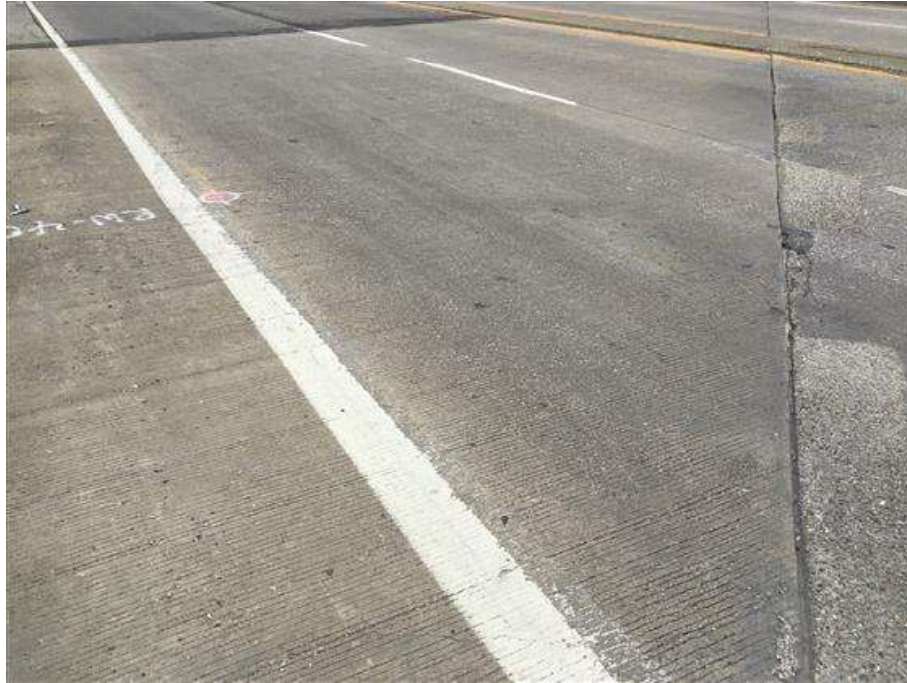
PHOTO 7

Description West approach slab and Type 1A joint overall condition, eastbound lanes

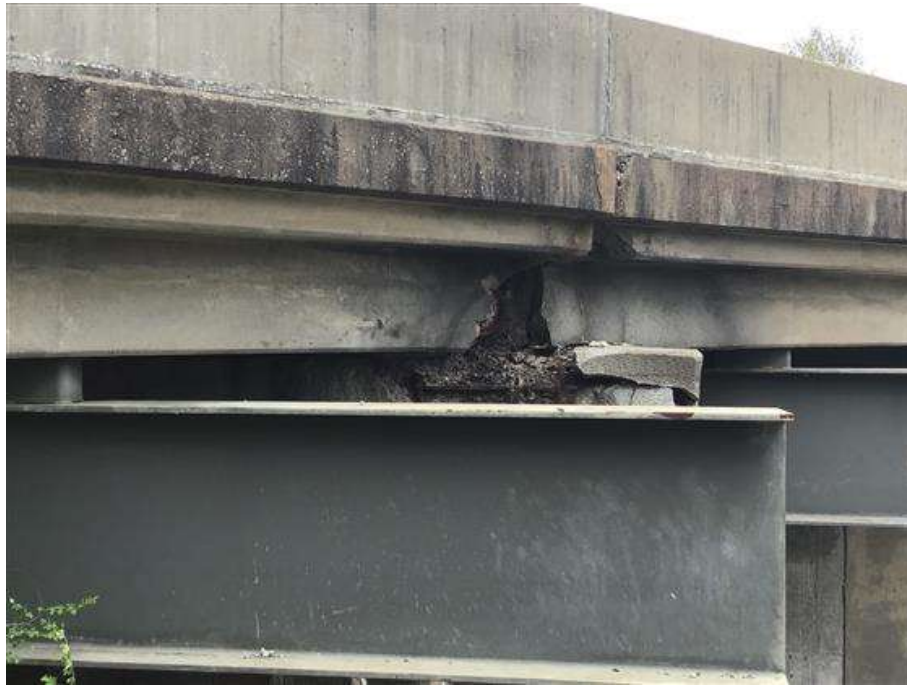
PHOTO 24

Description Deterioration on south end of original Pier 2

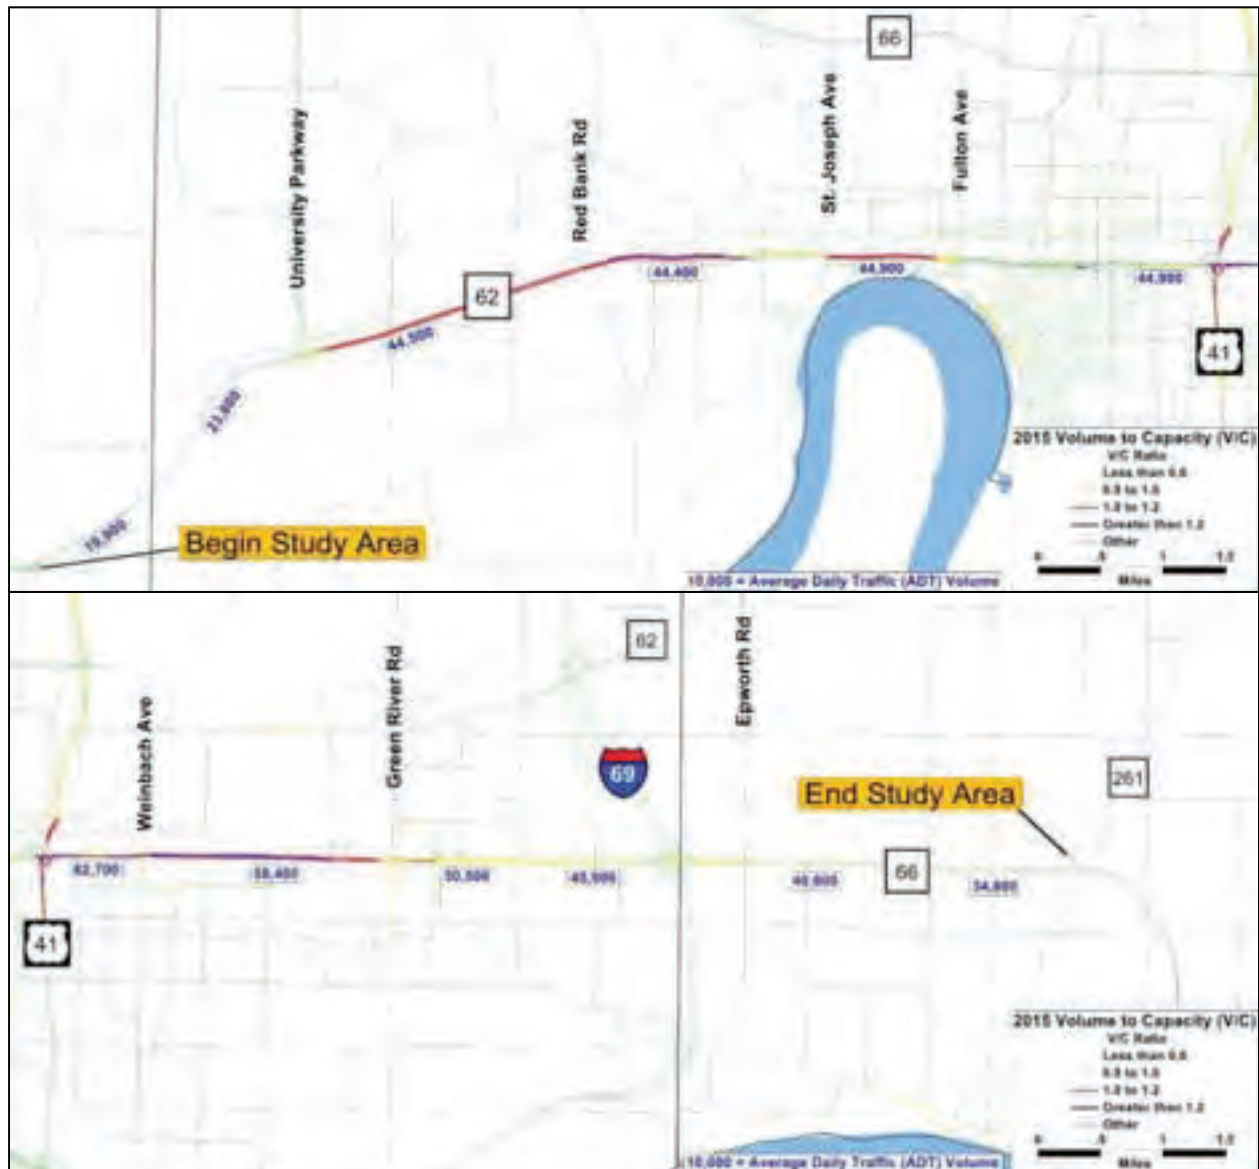
Figure 2.10 Latest Average Daily Traffic (ADT) Counts and Volume to Capacity (V/C) Ratios

Level of service (LOS) is a qualitative measure describing operational conditions within a traffic stream, based on service measures such as speed and travel time, freedom to maneuver, traffic interruptions, comfort, and convenience. There are six levels of service, which include letter grade scoring of A through F. LOS A is associated with free-flow conditions, high freedom to maneuver, and little or no delay. Conditions at or near capacity typically are associated with LOS E. At LOS F, traffic conditions are oversaturated and exceed capacity, with low travel speeds, little or no freedom to maneuver, and high delays. In urban areas, LOS D or better is desirable.

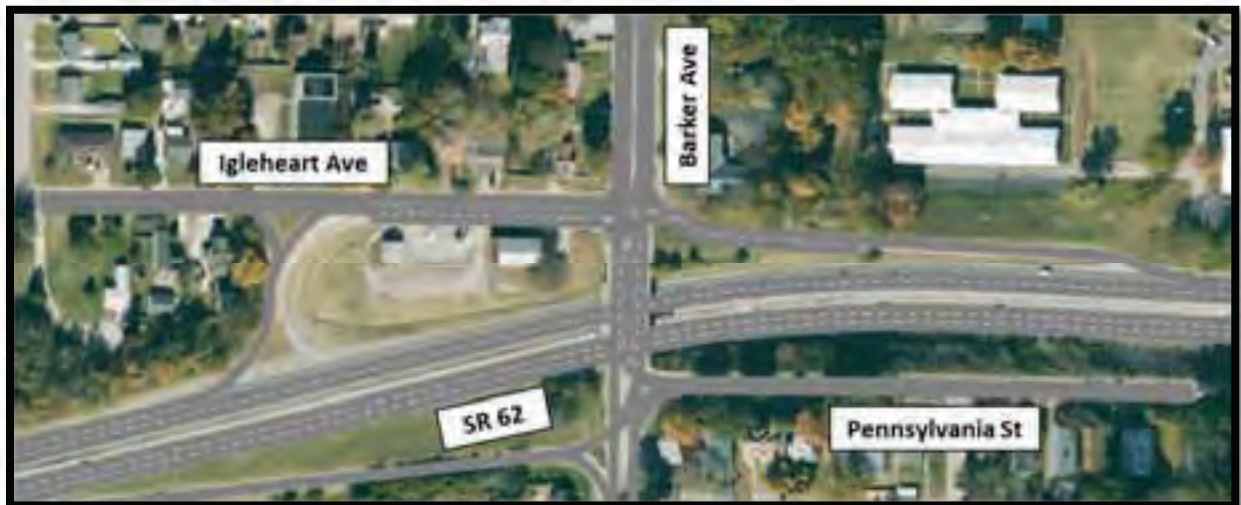
Additionally, with a third continuous auxiliary lane between the Corbierre Avenue westbound exit ramp and the Igleheart Avenue westbound entrance ramp, it is recommended that the third westbound SR 62 through lane drop as an exit-only lane at the eastern Barker Avenue exit ramp. The preferred alternative lane configurations for the interchange are illustrated in **Figure 13**.

Figure 13. Barker Avenue Interchange Alternative Configuration (VISSIM)

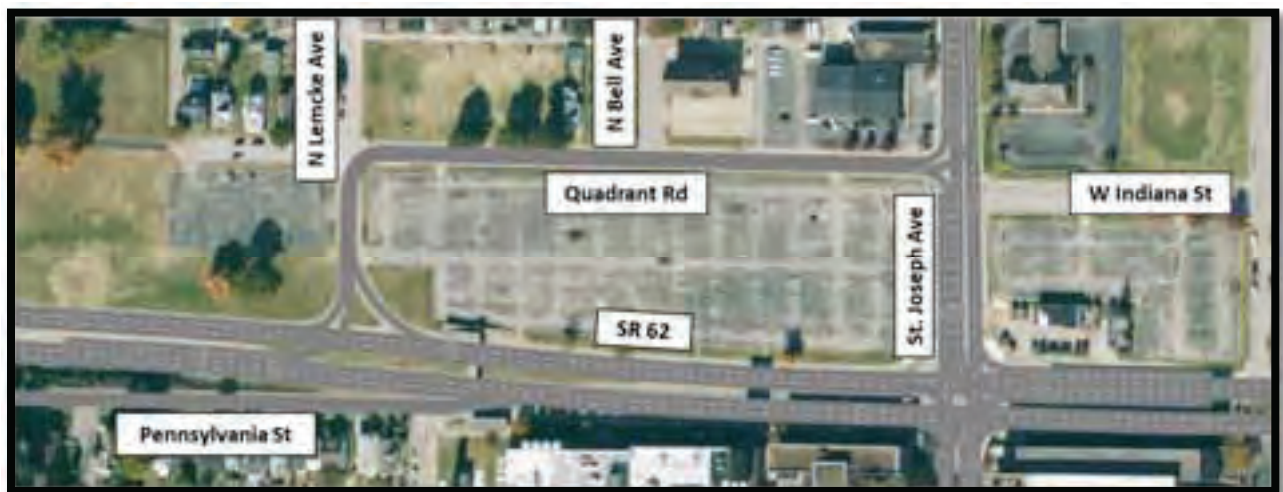
Re-routing other movements through the quadrant road to remove additional left turn phases from the main intersection, such as the westbound left turn or northbound left turn, were considered, but ultimately not recommended as part of the northwest quadrant road intersection alternative. Re-routing northbound left turns through the quadrant road would require a northbound left turn phase at the northern quadrant road intersection with St. Joseph Avenue, diminishing the efficiency of that intersection. Additionally, there is limited room to add a northbound left turn lane to the north leg of St. Joseph Avenue at SR 62. Re-routing westbound left turns through the quadrant road would require motorists to pass St. Joseph Avenue, make a westbound right turn onto the quadrant roadway, an eastbound right turn back onto St. Joseph Avenue, and then proceed southbound through the main intersection at SR 62. This maneuver could be acceptable to passenger vehicles; however the westbound left turn movement is heavily utilized by trucks accessing the industrial land uses to south of SR 62. It would not be advisable to require heavy truck traffic to make this maneuver. Therefore, the westbound left turns remain at the main intersection of St. Joseph Avenue and SR 62.

Figure 15. SR 62 and St. Joseph Avenue Quadrant Road (VISSIM)
